FIELDTRIP 3

AN INTRODUCTION TO SUNNY MATATA AND ITS GREAT DEBRIS FLOWS

THE 18 MAY 2005 DEBRIS-FLOW DISASTER AT MATATA: CAUSES AND MITIGATION SUGGESTIONS

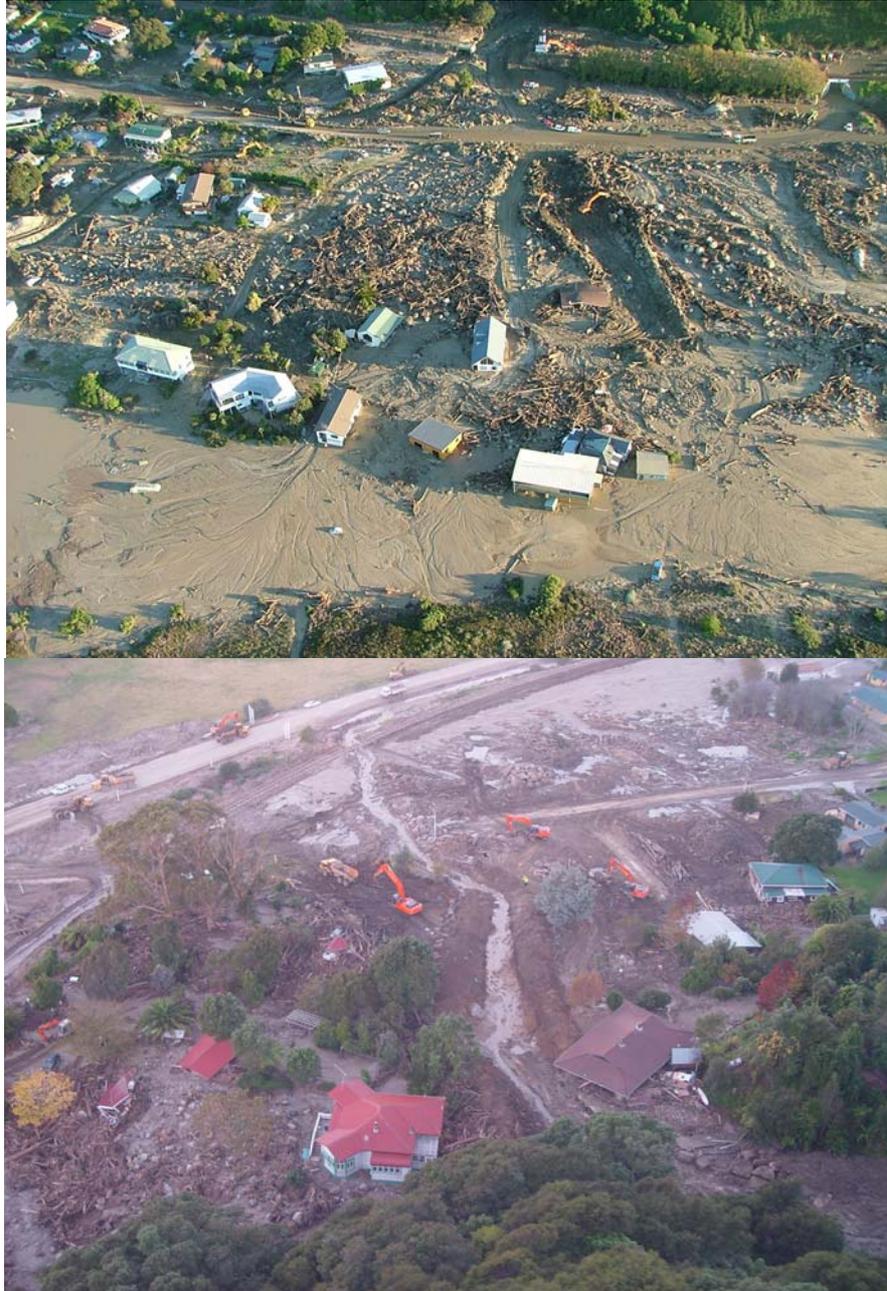
The 18 May 2005 debris-flow disaster at Matata. *Debris flow* damage at Awatarariki (top) and Waitepuru Streams (base).

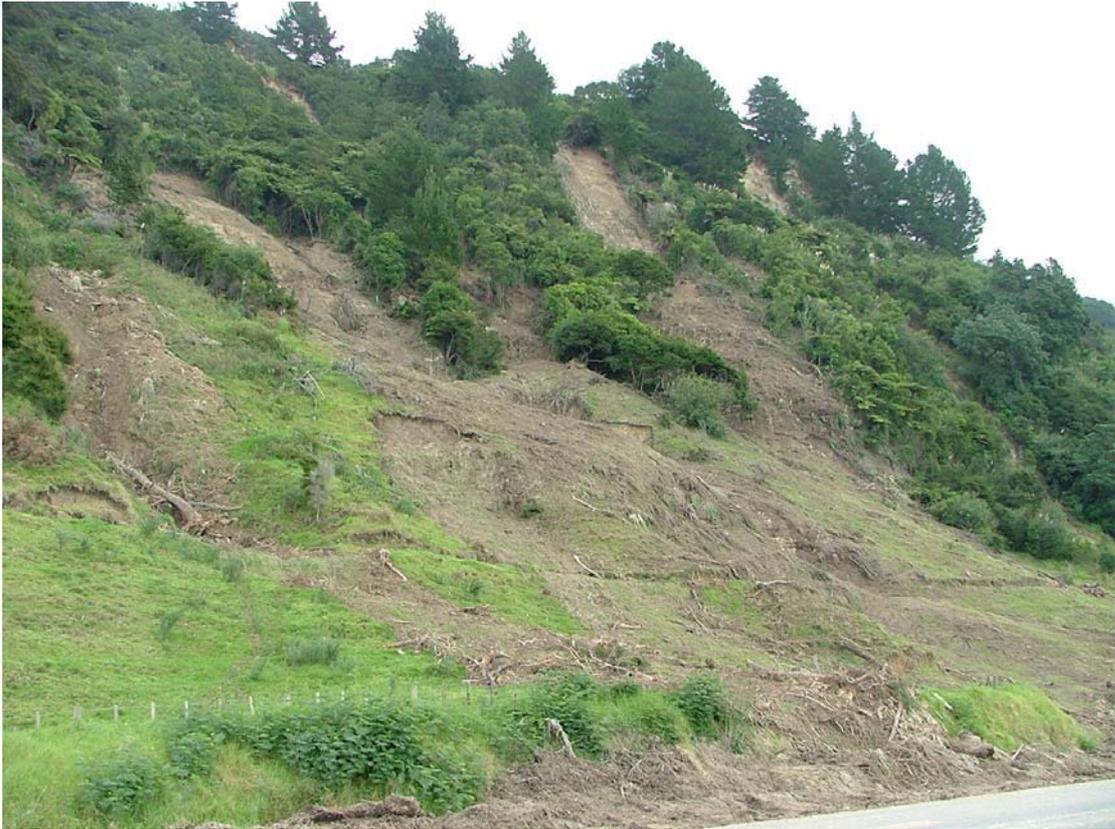
Debris avalanches from the old sea cliffs just north of Matata.

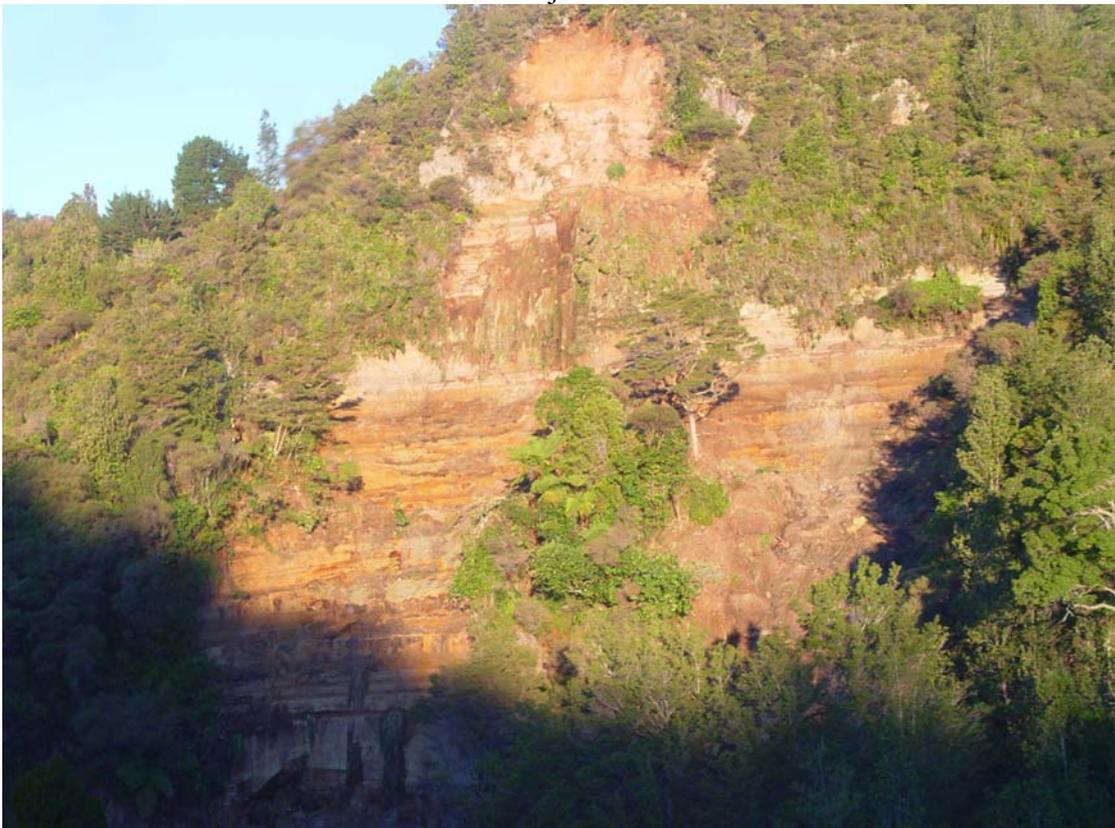
Numerous *debris avalanches* in the upper Awatarariki Stream coalesced to form the *debris flow*.

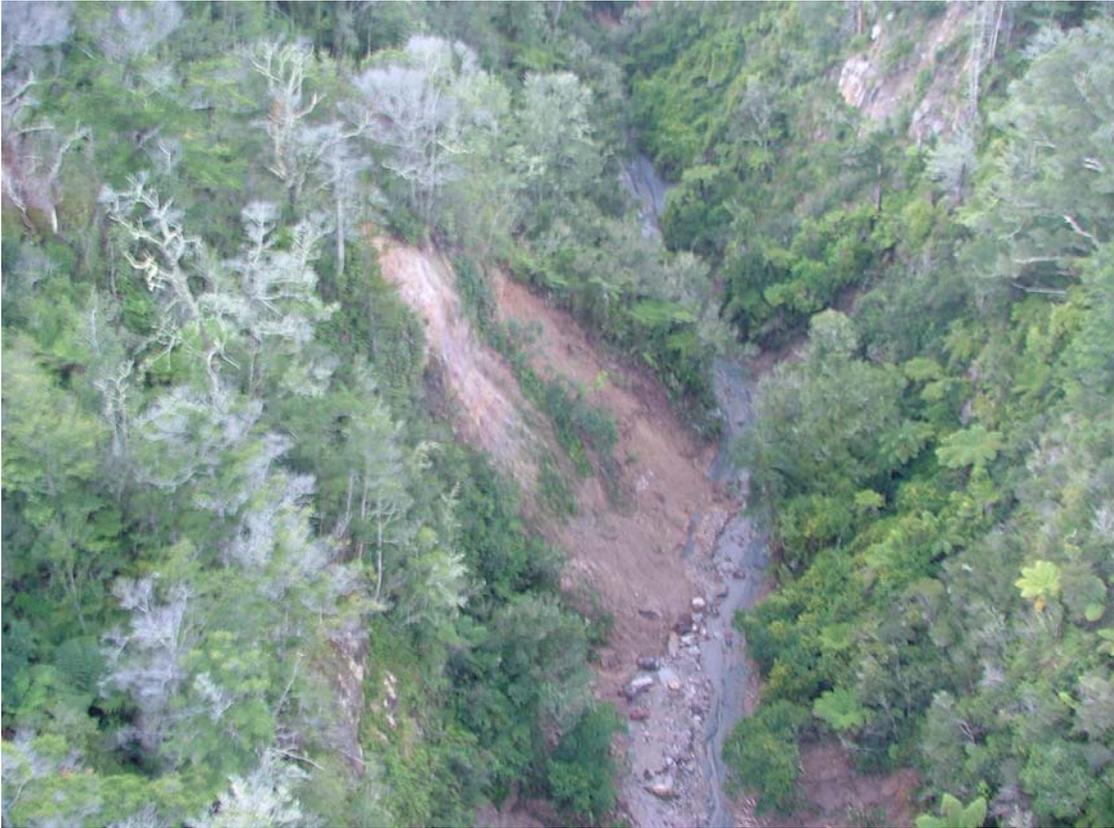
Examples of *debris avalanches* into the Awatarariki Stream behind Matata.

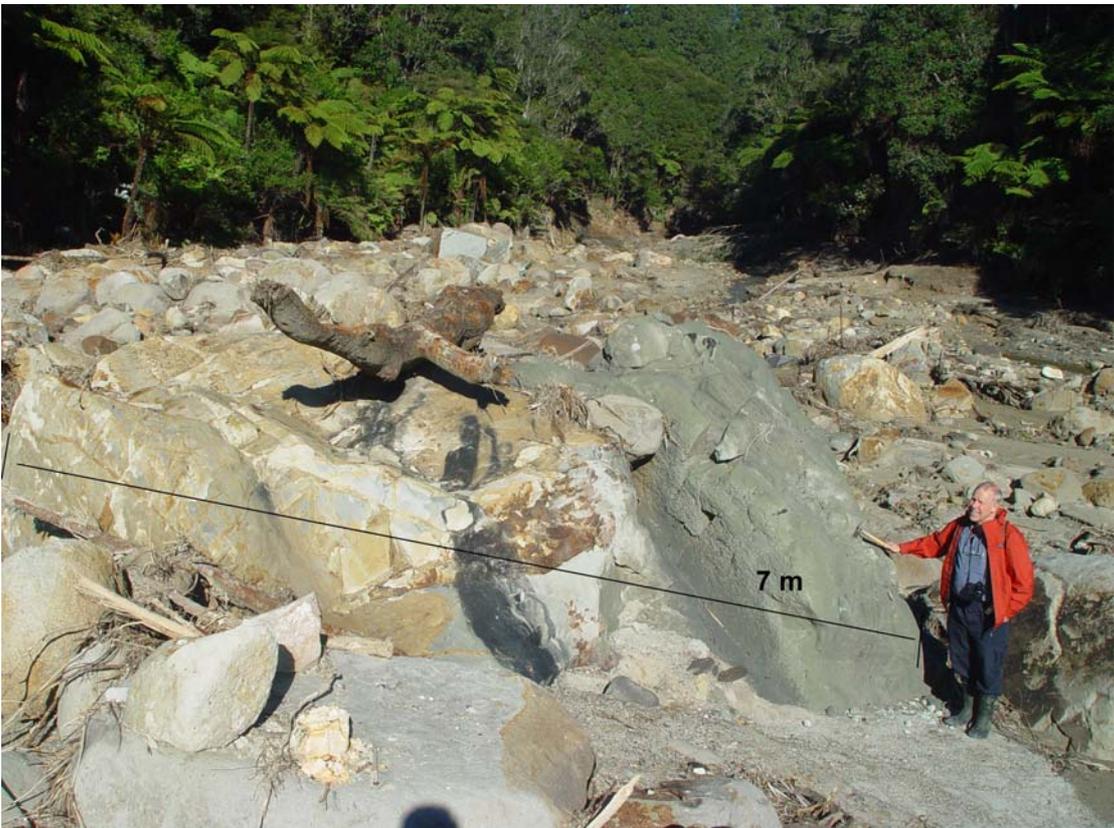
The largest boulder seen that was carried by the *debris flow* in the Awatarariki Stream is about 7m across.

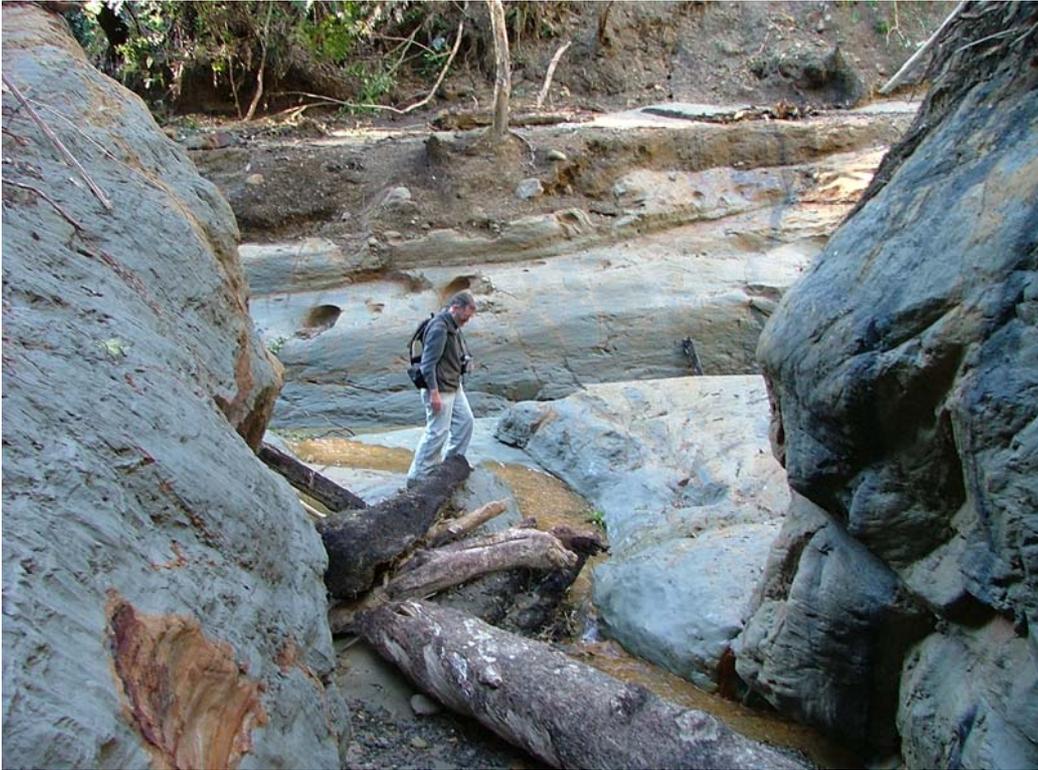
The main stream and a tributary of the Awatarariki, both cleaned out by the erosive power of the *debris flows* that passed down them.

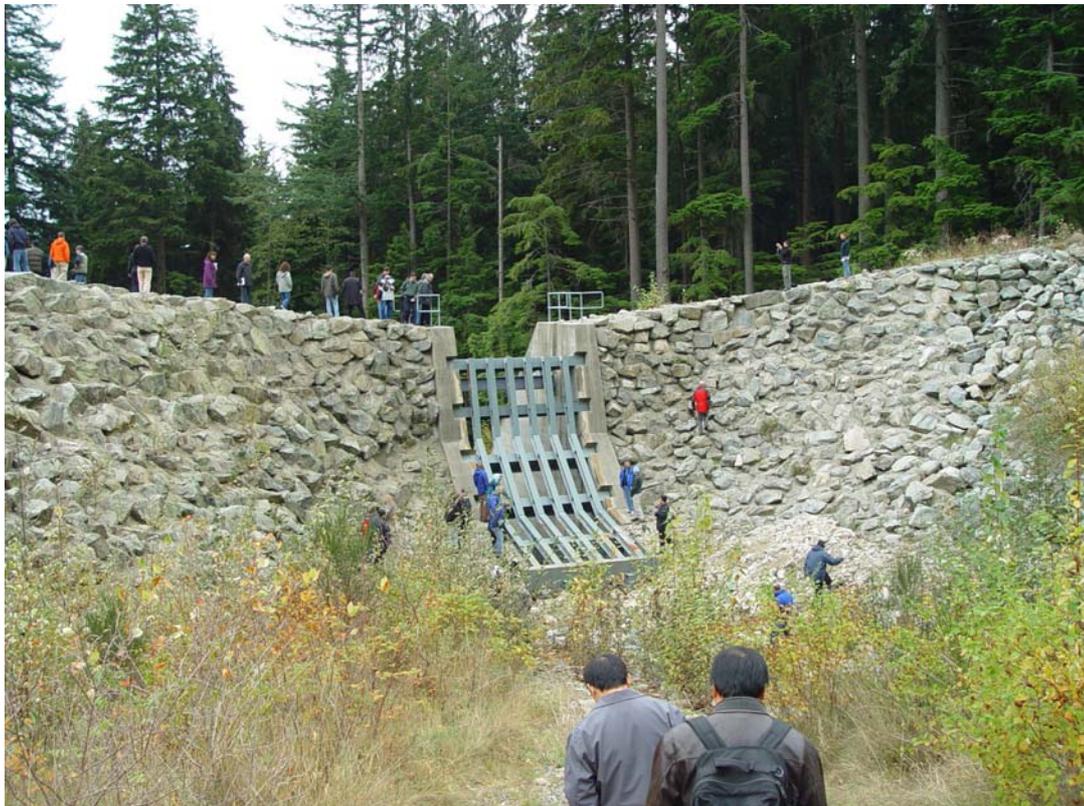
A debris-flow detention structure protecting a suburb of Vancouver, Canada, that may be a suitable model to trap debris-flow boulders in the former quarry area of Awatarariki Stream.
